NAF Bruktbiltest

Testdato
27.03.2025

Bilmerke	BMW	Motorstørrelse	2993 cm ³
Modell	730D	Motoreffekt	180 kW
Type	7L	Aksler i drift	1
Registreringsnr.	BS69997	Drivstofftype	Diesel
Understellsnr.	WBAKM21070C333878	Kjøretøygruppe	101
Km.stand.	176321	Bruktimportert	Ja
Farge	Sølv	Registreringsår	2009
Karosseritype	Sedan	Registrert første gang	23.12.2009
		Frist for neste EU kontroll	13.06.2025

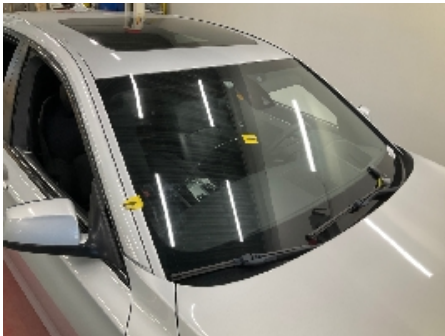
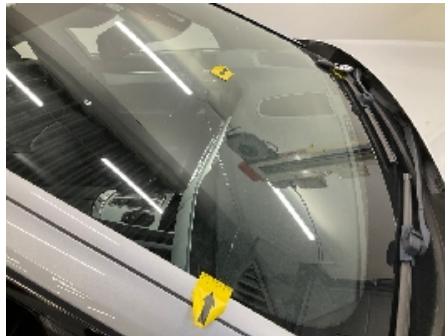
81.4	Frontrute	Sprekk i frontrute: <ul style="list-style-type: none">• Reparasjonsmetode: Skift	
86.13	Lakk / karosseri utvendig	Lakkslipp/flassing	Støtfanger foran, Venstre fordør, Venstre sidekanal

1. Frontrute

2. Frontrute

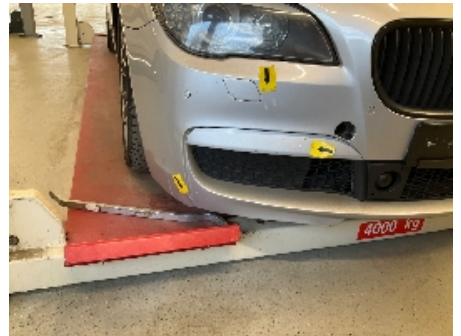
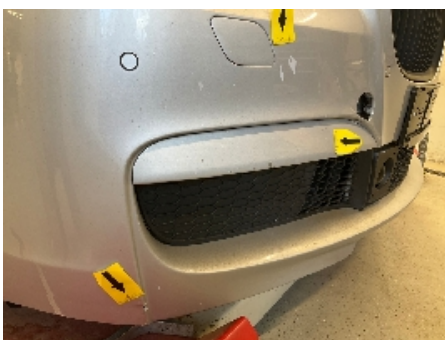
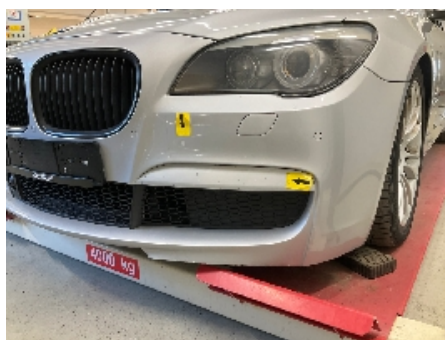
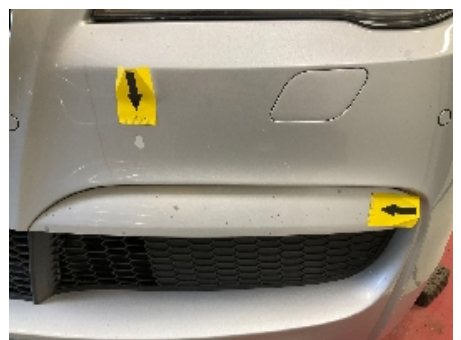
3. Støtfanger foran

4. Støtfanger foran

5. Støtfanger foran

6. Støtfanger foran

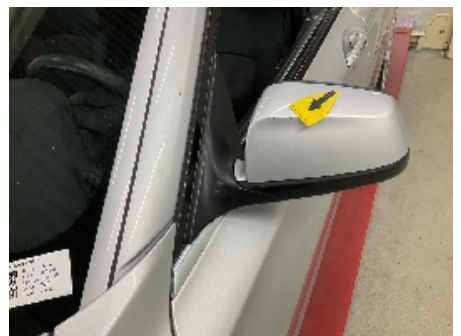
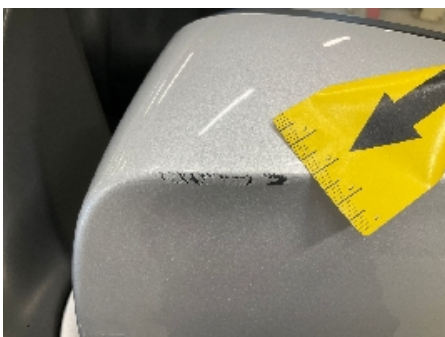
87.5	Utvendig speil	Skade på speilramme / -hus	Venstre side
88.2	Underside	Skadet/løst plastdeksel:	Midten foran
103.1	Interiør generelt	Forurensing og/eller ubehagelig lukt

9. Venstre speil

10. Venstre speil

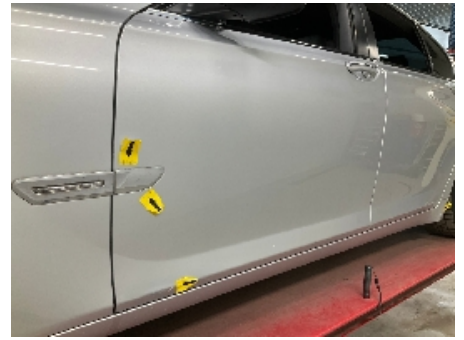
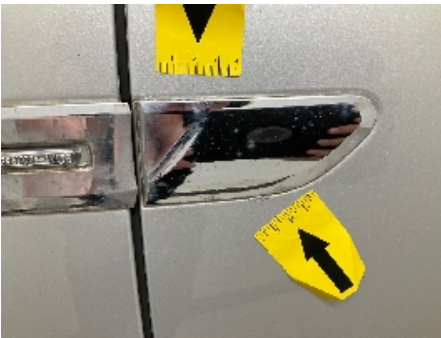
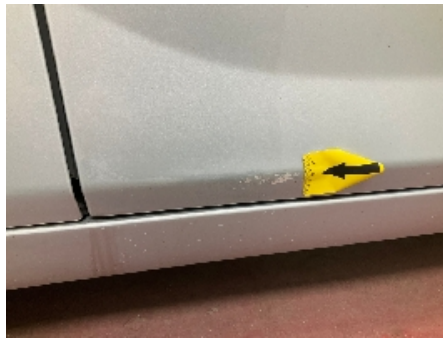
15. Venstre fordør

16. Venstre fordør

17. Venstre fordør

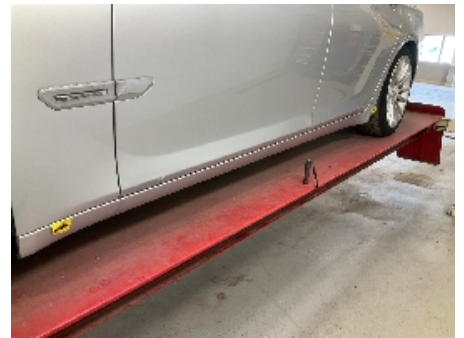
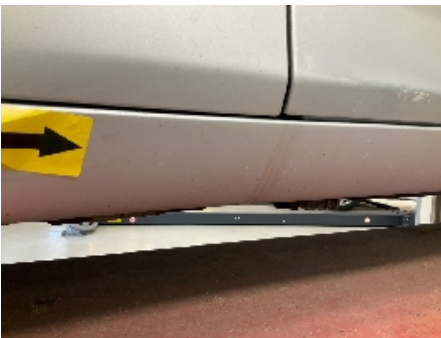
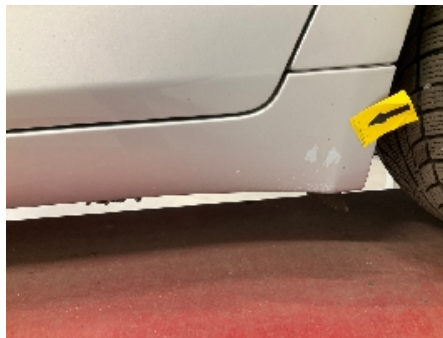
18. Venstre kanal

19. Venstre kanal

20. Venstre kanal
