# NAF Bruktbiltest

| Modell | 208 | Motoreffekt | 100 kW |
| Registreringsnr. | EE15263 | Drivstofftype | Elektrisk |

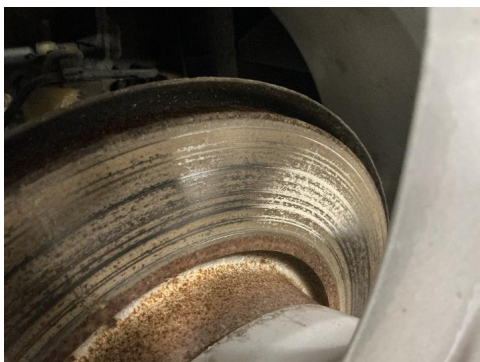
22. Bremseskiver

| Ref.Id | Repareres | Resultat | Beskrivelse |
|---|---|---|---|
| 6.10 | Bremseskiver | Rust på bremseskive: | Venstre bak, Høyre bak |
| 6.16 | Bremseskiver | Overflaterust eller mindre enn 25% av overflaten rustet | Begge sider foran |

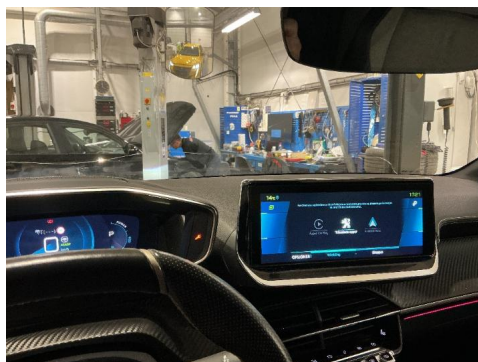
R 23. Frontrute

| Ref.Id | Repareres | Resultat | Beskrivelse |
|---|---|---|---|
| 81.4 | Frontrute | Sprekk i frontrute: <ul style="list-style-type: none"><li>• Reparasjonsmetode:Skift</li></ul> | |

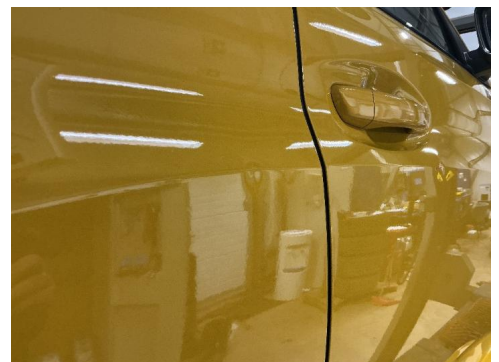
R 24. Høyre bakdør

| Ref.Id | Repareres | Resultat | Beskrivelse |
|---|---|---|---|
| 86.6 | | Bulk (er): | Høyre bakdør, Venstre baksjerm, Høyre fordør, Høyre baksjerm |

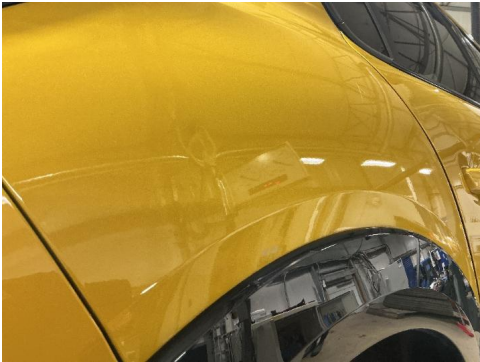
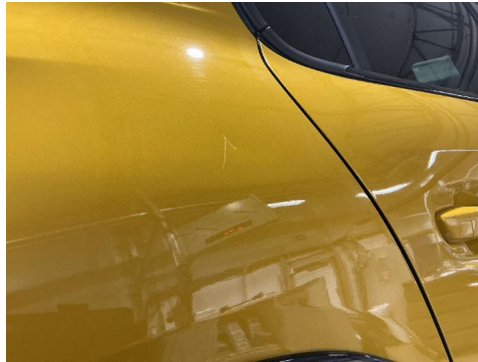
**R** 26. Høyre bakskjerm

| Ref.Id | Repareres | Resultat | Beskrivelse |
|---|---|---|---|
| 86.3 | Lakk / karosseri utvendig | Lakkriper: | Høyre fordør, Høyre baksjerm |

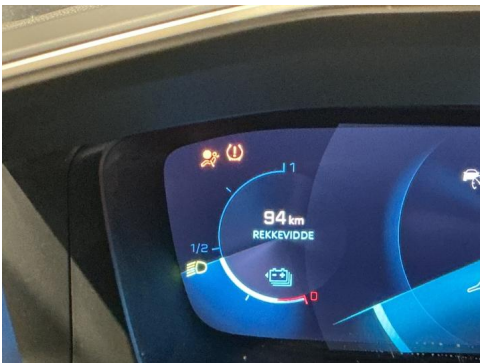
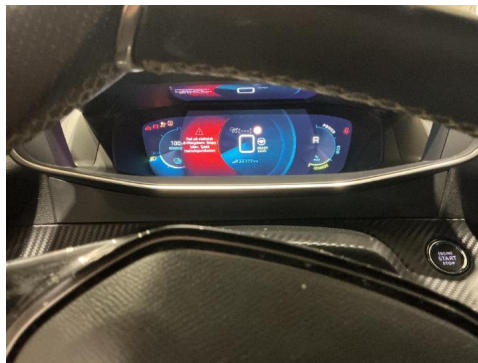
**R** 29. Varsellamper

| Ref.Id | Repareres | Resultat | Beskrivelse |
|---|---|---|---|
| 21.3 | Varsellamper | Varsellampe for SRS (airbag) lyser | |
| 22.2 | Varsellamper utvidet | Varsellampe for TPMS (Dekktrykk) lyser | |
